## Feedback on the Leatherhead-Ashted cycle route

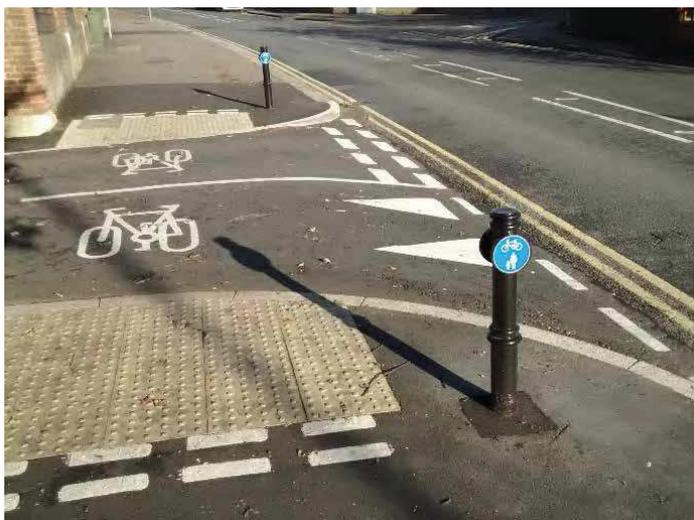
For this to work well though the bollards need to be positioned close to the edge of the road where they are not obstructing the cycle path. There are many good examples on the route such as the entrance to St John's School (see picture on right).

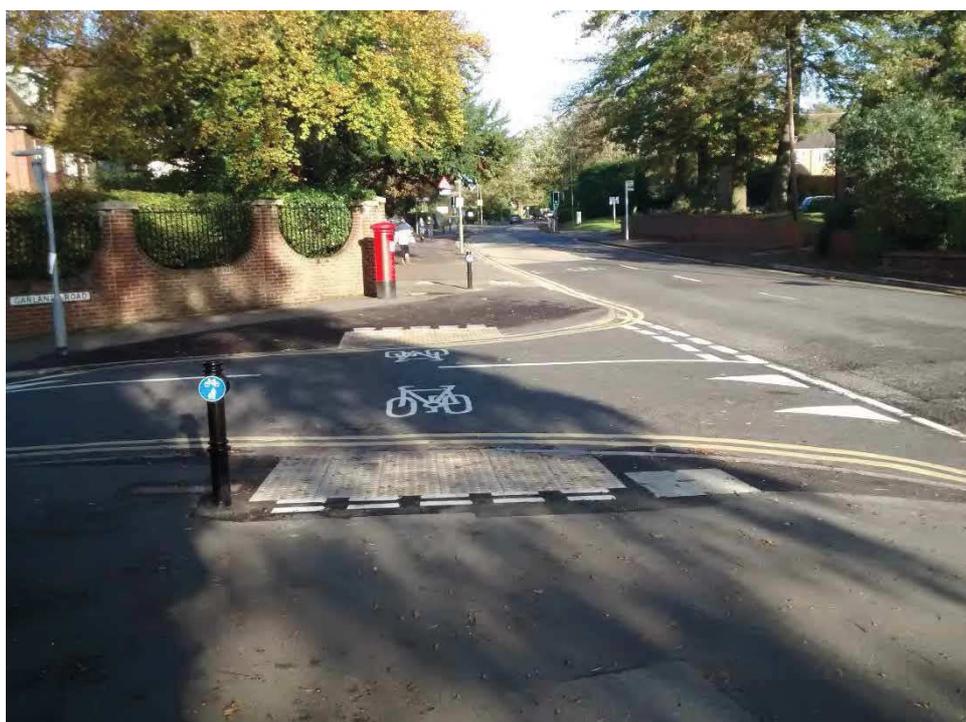
### Poorly positioned bollards (Garlands Road)

At Garlands Road, travelling north the first bollard is positioned to the left of the path and the other bollard is in the middle of the path. These should be repositioned at the edge of the road.

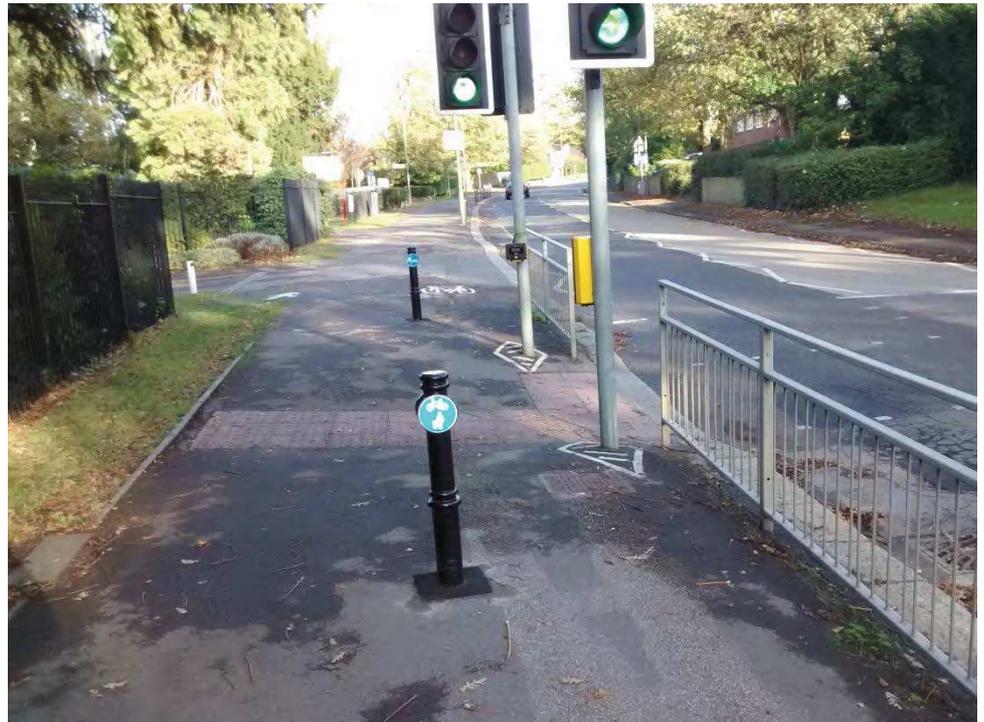
Continuing north, there are several bollards in the middle of the path (see also [Unnecessary segregated path section](#) below). These bollards are particularly dangerous since they force the different path users into conflict. There is also the potential danger for people on bikes colliding with these bollards, especially at night.

The bollards at the Fortyfoot Road crossing are particularly dangerous since this is a busy area with large numbers of school children both crossing the road and using the path.

**Bollards in the middle of the path (crossing opposite Fortyfoot Road)**

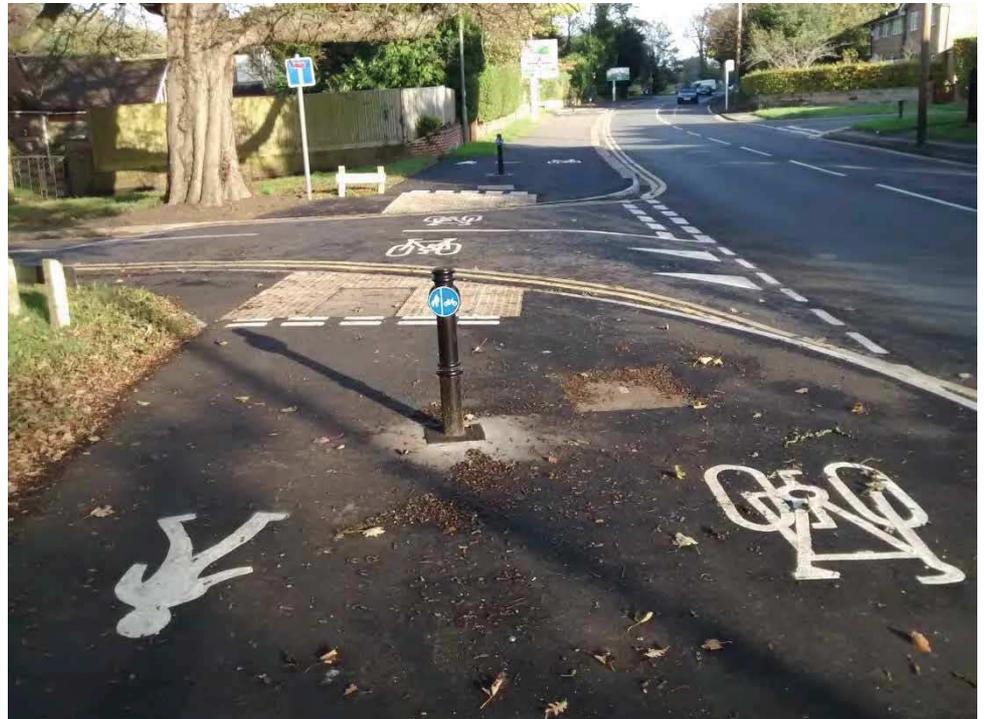
**Bollards in the middle of the path (entrance to Homelands)**

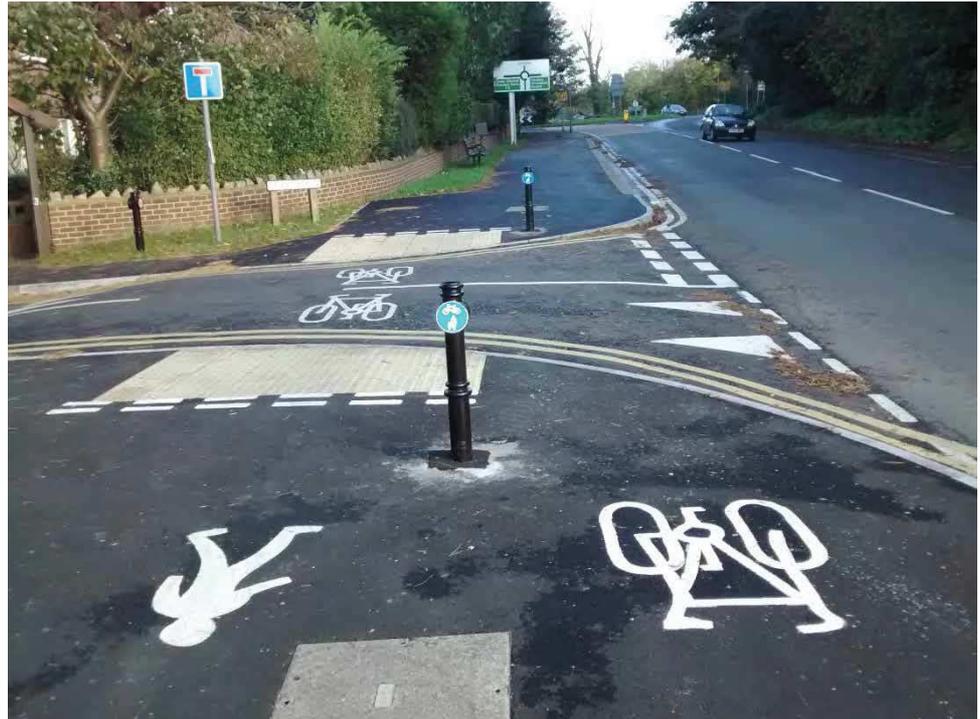
**Bollards in the middle of the path (entrance to Melvinshaw)**

The dropped kerbs and give way markings are in any case not lined up with the “bicycle” side of the segregated path (see photo of entrance to Melvinshaw on page 4). This section of the path should be made shared-use like the rest of the route.

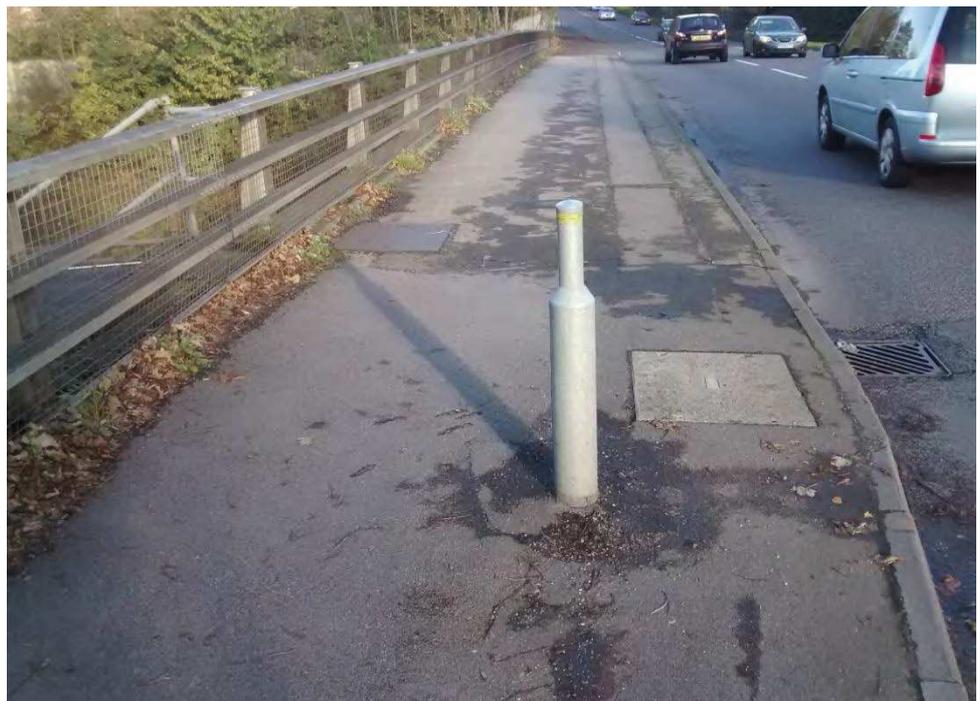
On the start of the bridge over the motorway there is a short grey post in a dangerous position in the middle of the path.

**Post in the middle of the path (crossing the M25)**

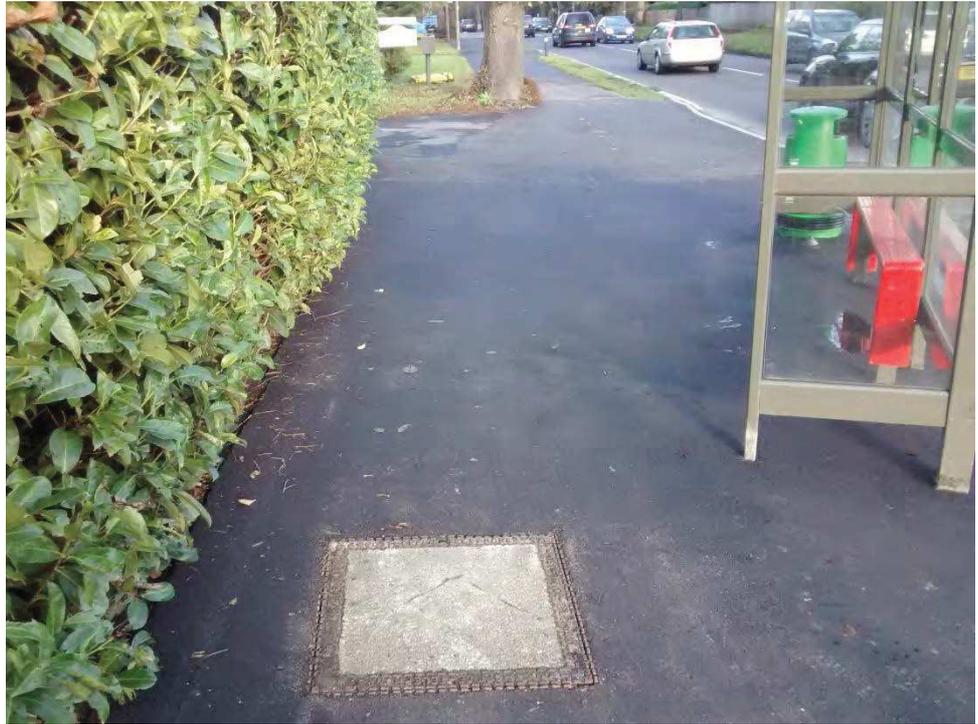
By the bus stop north of Grange Road the gap between the new shelter and the hedge is too narrow. At just over 1.5m this is well under the guidance of 3m for busy shared-used paths.

**Narrow section of path by bus shelter (north of Grange Road)**

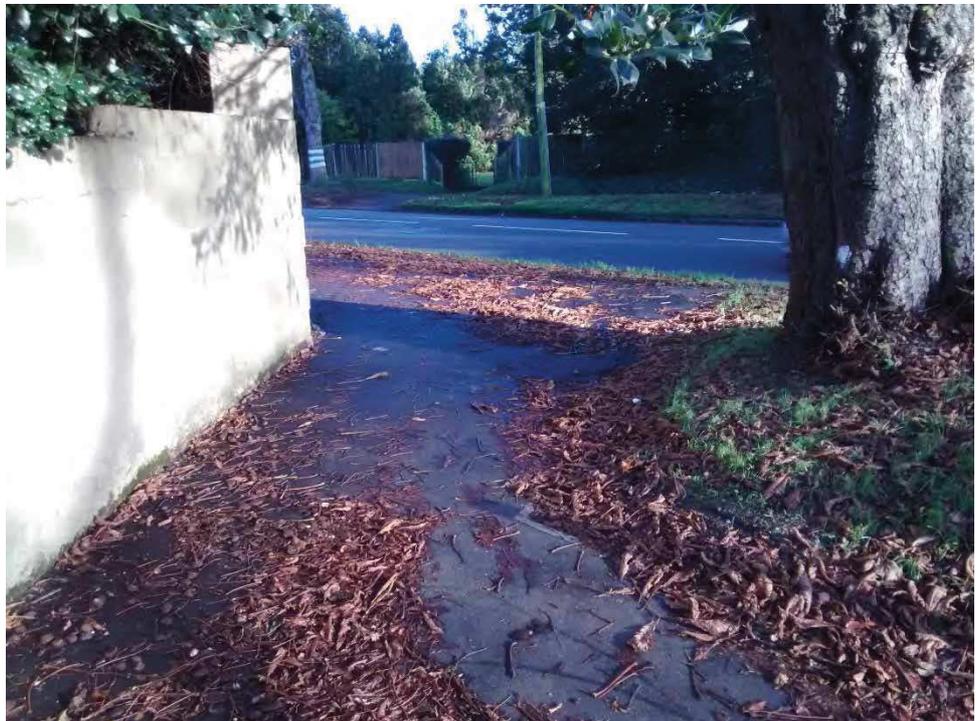
At Uplands, the path is very narrow where it diverts past a tree. There are clear indications that people are already having to cut across the edge of the grass.

**Narrow path (entrance to Uplands)**

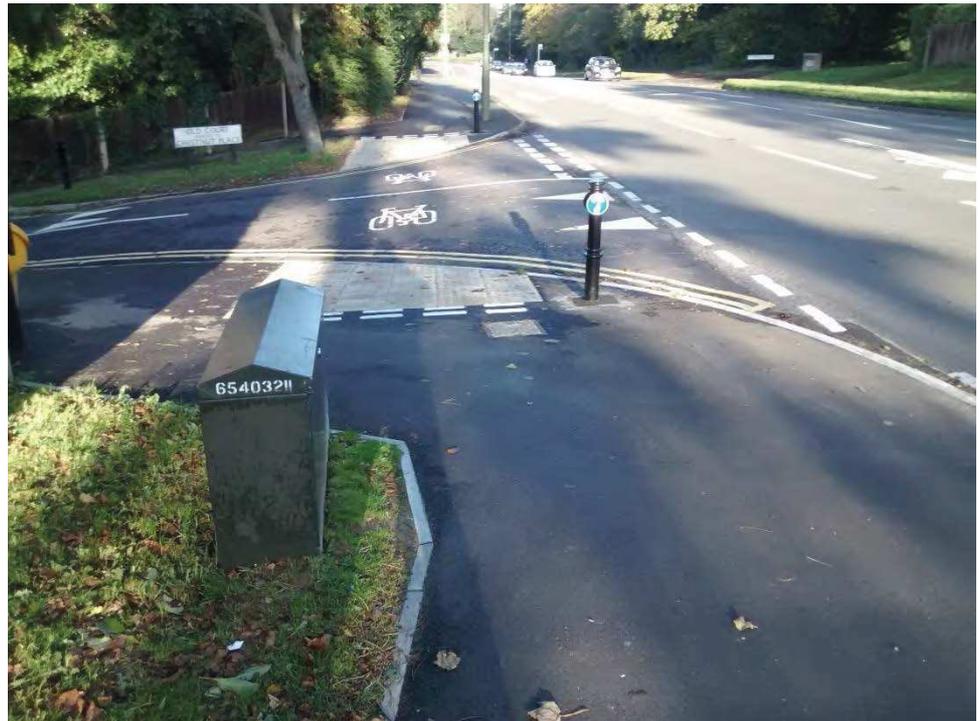
At the entrance to Old Court, the path is obstructed where it passes a telecoms circuit box.

**Obstructed path  
(entrance to Old  
Court)**

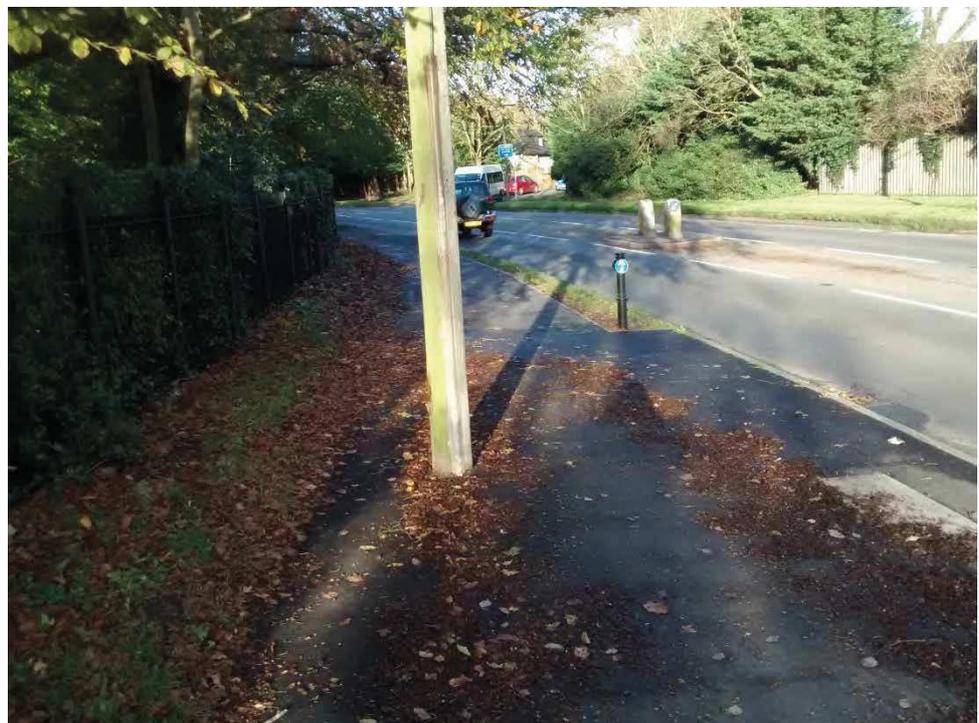
Opposite the entrance to Ashted Hospital there is a telegraph pole in the middle of the path. This is particularly hazardous and there is a high risk of people colliding with it, especially since it is partially shaded under the trees.

**Telegraph pole in the  
middle of the path  
(opposite Ashted  
Hospital)**

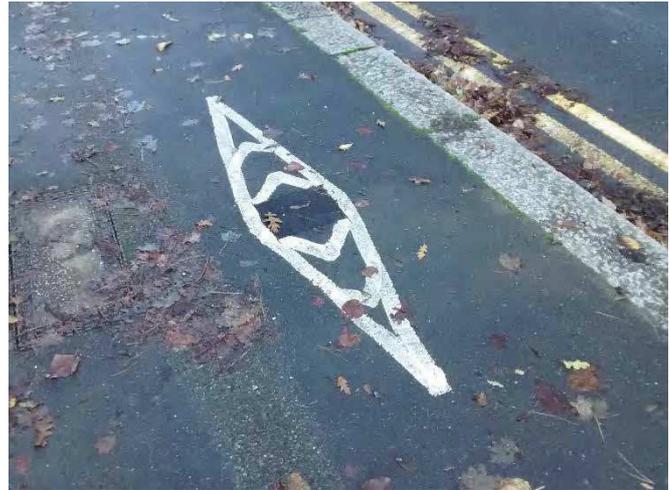
Some posts have markings on only one side. There are also some markings on the path for posts which are no longer there (see picture on right).

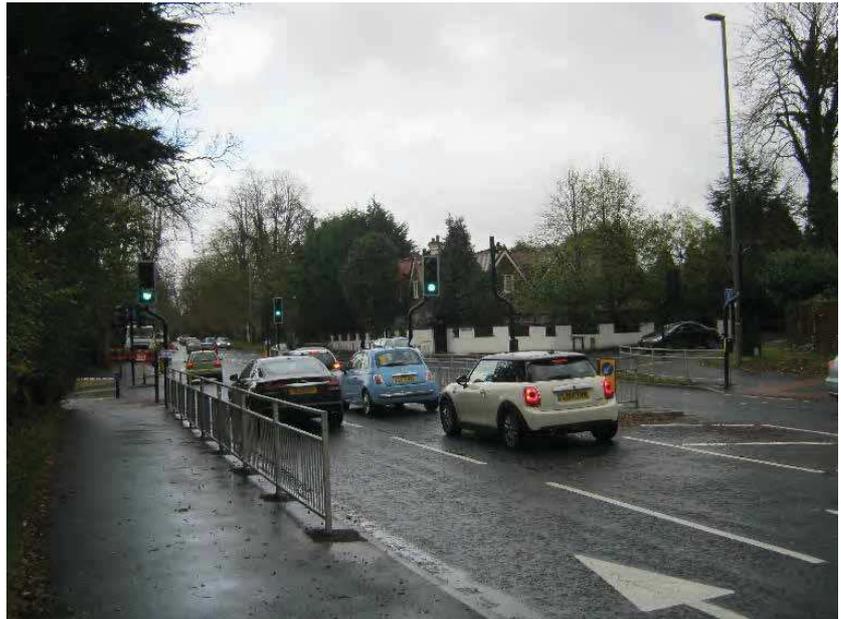
There are no signs for road users indicating that vehicles are crossing a busy cycle path (other than a temporary "New road layout ahead" sign).

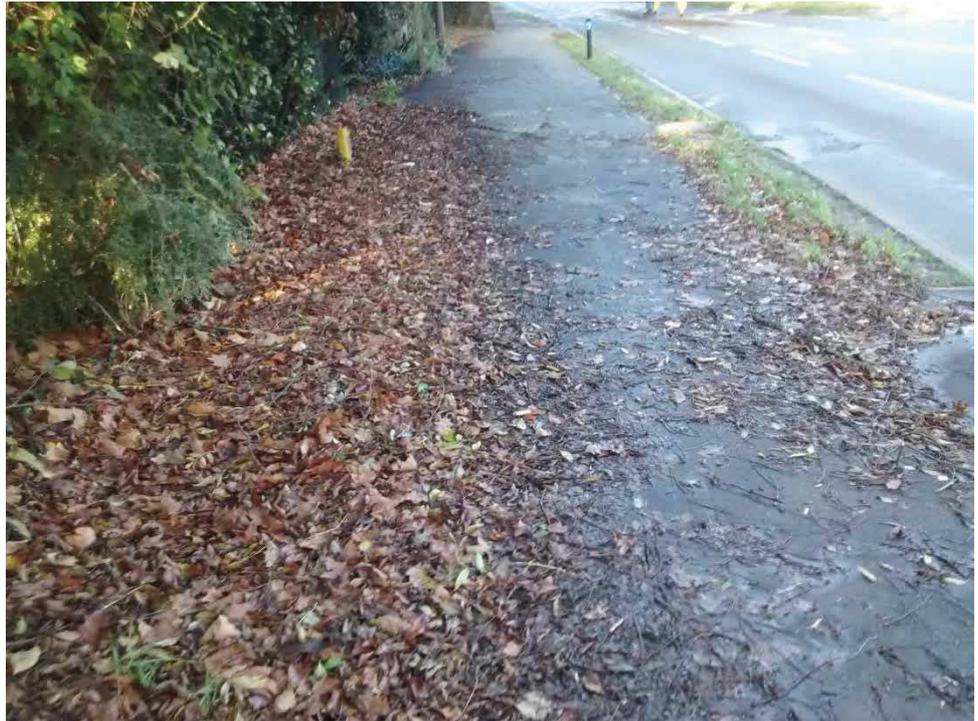
In places the path has already become coated with soil and fallen leaves. The full width of the path will need to be regularly cleared to maintain the path width and to keep the surface from becoming slippery. At night and after rain this is a particularly important. In places over half the width of the path has been obscured.

**Fallen leaves  
obscuring the path  
(opposite The Warren)**

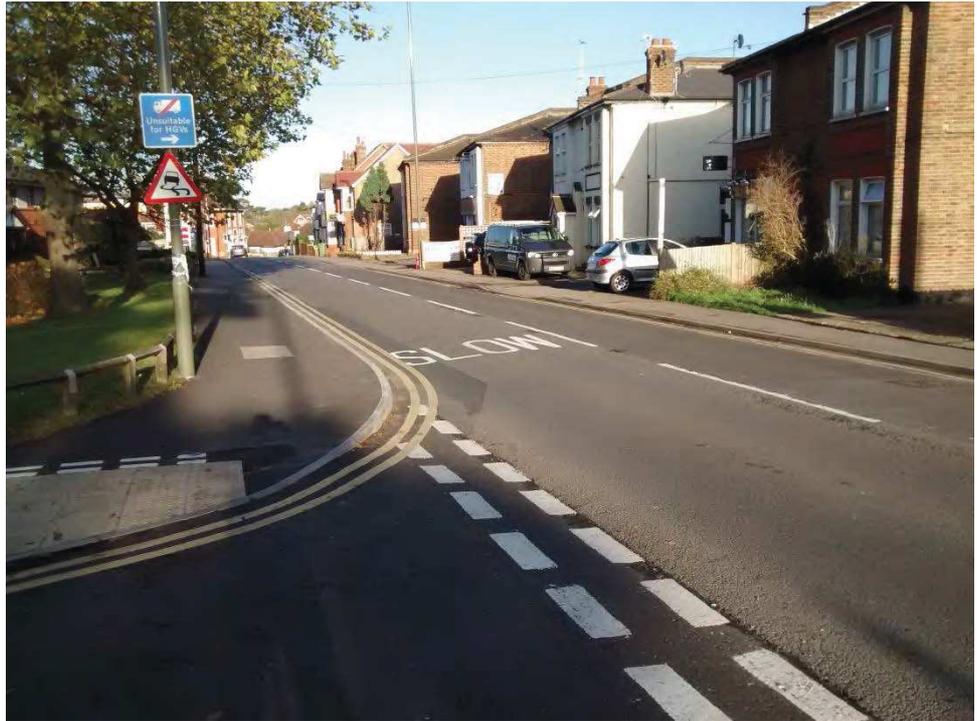
Approaching Ashted the route stops several hundred metres from the village. This is precisely at the most dangerous and unpleasant point on the route where the road narrows and bends and there is a hill on the exit from the village. Few people will choose to ride on the road at this point. There is effectively no access to Ashted for the types of cyclists (families, children and the elderly) this route is designed to attract.

**Northern end of the route (500 metres south of Ashtead)**

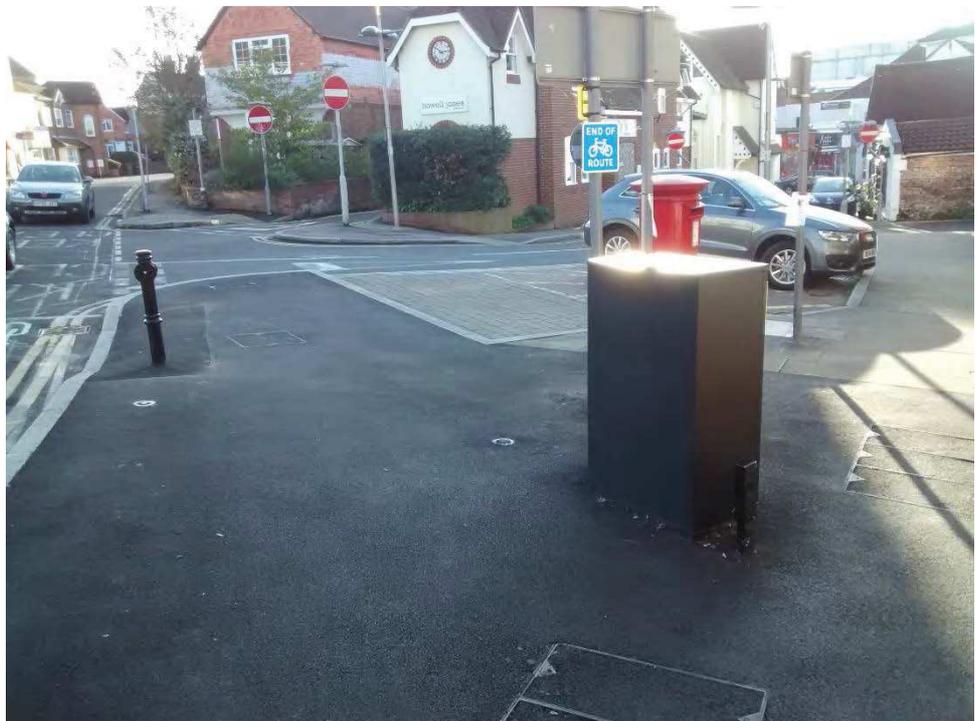
The access to Leatherhead is confusing and uninviting. The route ends at the top of the High Street and there is no obvious way of accessing the town centre.

**Southern end of the route (top of Leatherhead High Street)**
