ADJUSTMENT TO NARROW CYCLEPATH ALONG A24 FROM GIVONS GROVE
ROUNDBABOUT TO MICKLEHAM.

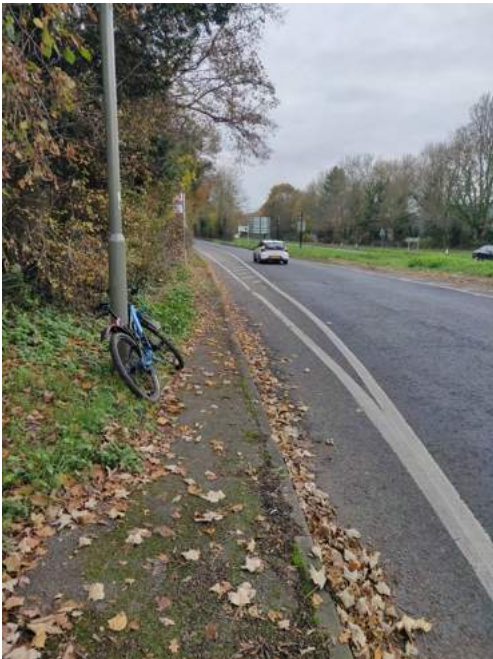
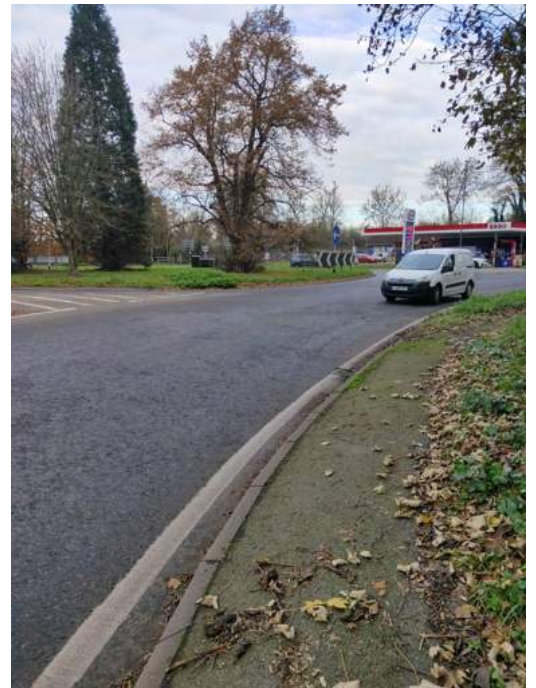
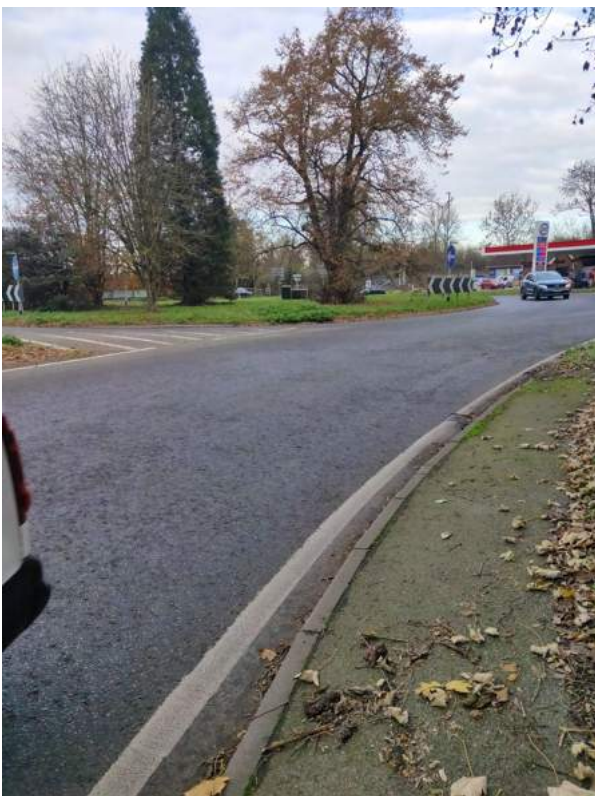
Below. This shows "cyclepath" the writer uses two or three times a week. It is unnecessarily narrow to start with and can have stones branches and other detritus and be overgrown as other pictures here show.

In the interests of safety there is no reason why this path could not be 150 -200 centimetres wide with a single raised barrier to protect the cyclists from the motor traffic. This would get closer to the national standard for cycle paths CD195 requiring 2 metres width.

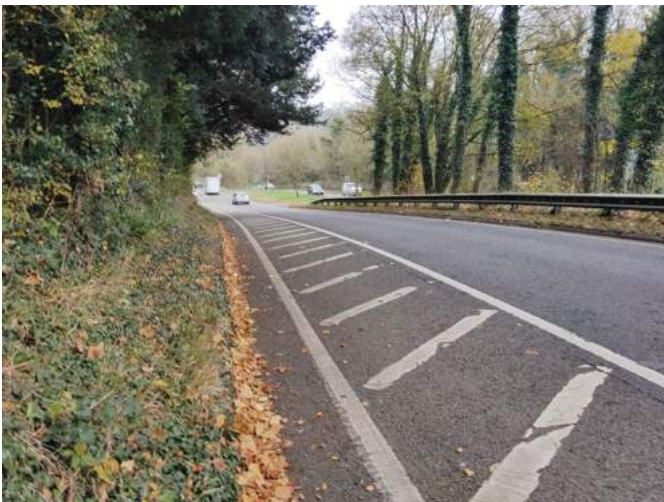
Right. The "cyclepath" with the bus/car pull in with a dangerous ceding of the priority to vehicular traffic on the main road

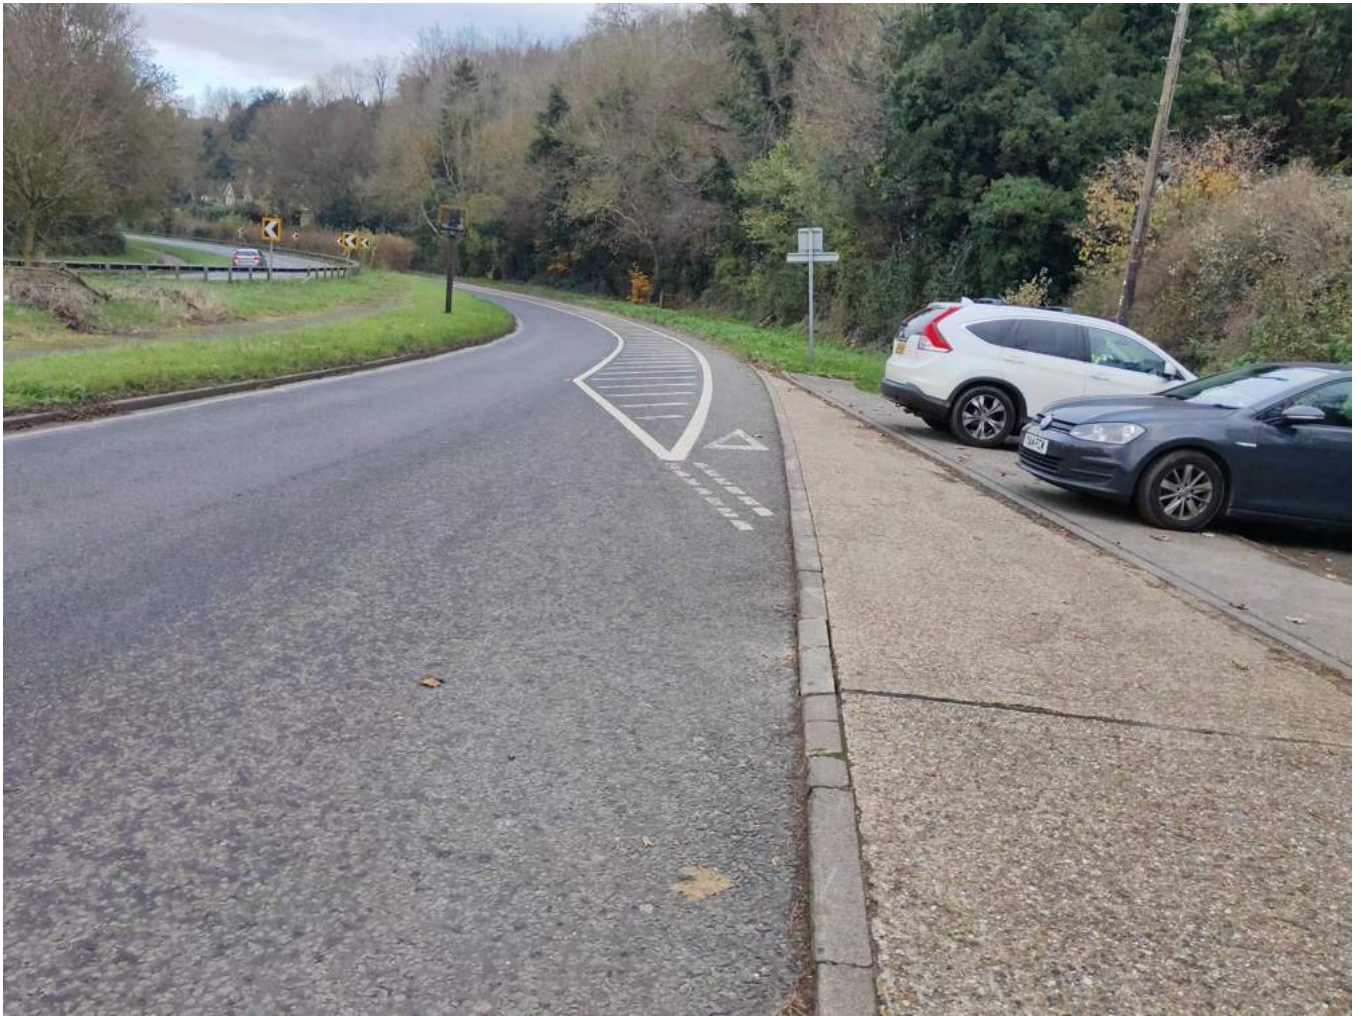
This picture shows a longstanding dangerous junction where the road planners expected the cyclist on the cyclepath to look behind him or her to check the approaching traffic. All approaching traffic but specifically anyone seeking to enter the bus stop or forecourt of the shop has elevated position clear screen forward vision and every easy provision to make adjustments while the cyclist does not. It is quite difficult to understand why this situation has maintained as is since the last contractor marked the road hatching with errors. This error remains.

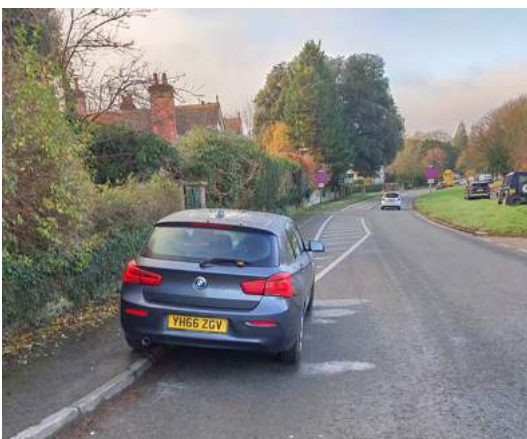
A24 heading looking southwards towards Mickleham showing car obstructing entry to cycle lane

An improved cyclepath would assist in stopping cars blocking the cycle path near Mickleham.

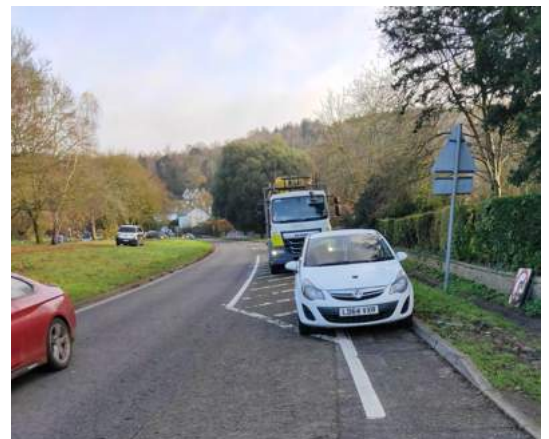
A24 looking northwards from Mickleham showing routine obstruction to cycle lane.

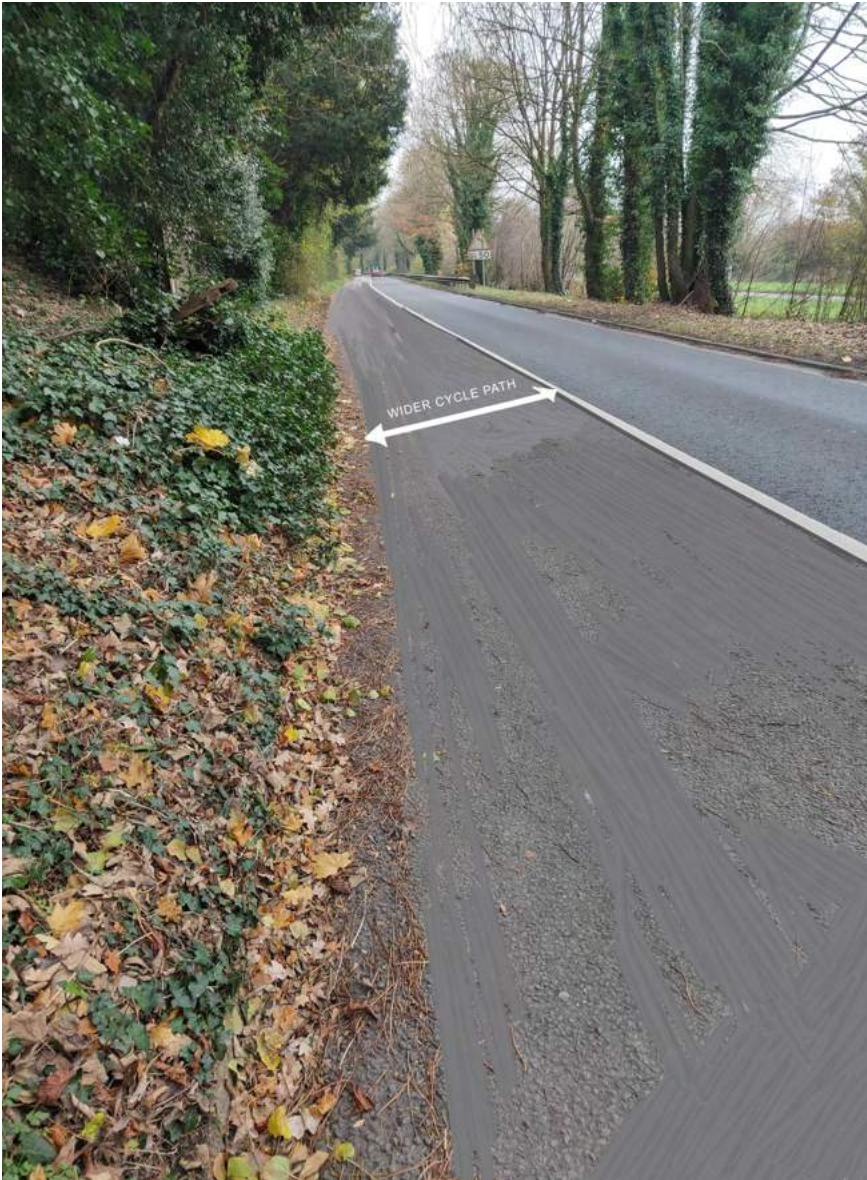
PROPOSED IMPROVEMENTS TO CYCLE ROUTE ALONG A24

This is an artists version of the re-arranged cycling facilities to improve on the current provision shown in the other photographs. It may well even approach the requirements of the National Standards for cycle path provision.

The most important feature of the new works is the raised kerb separating the cycle lane from the heavy vehicular traffic. This needs to be significant.
